# Neutralization of Acidic Discharges From Abandoned Underground Coal Mines by Alkaline Injection

By William W. Aljoe and Jay W. Hawkins

**Report of Investigations 9468**

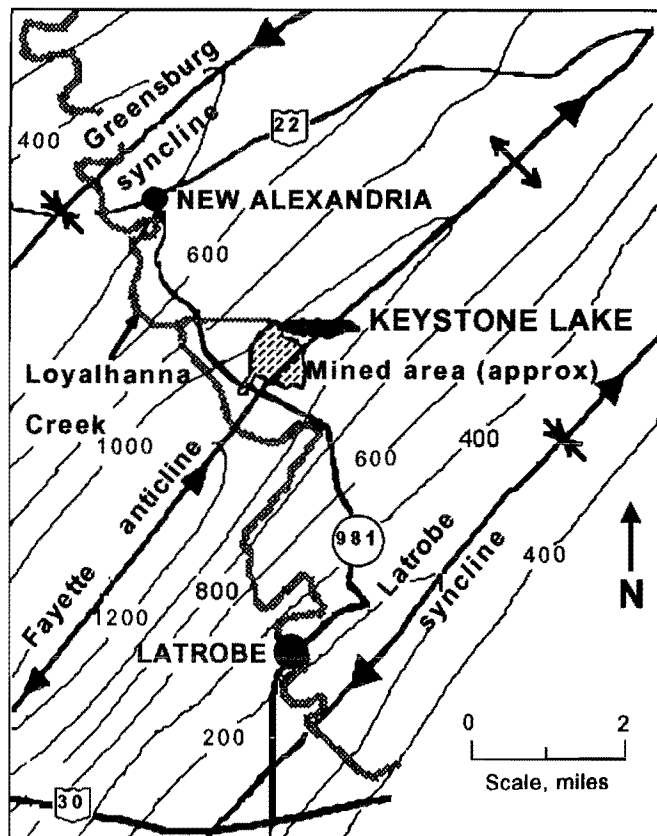
Figure 2.—Geologic structure of Keystone site; structure contours on Upper Freeport Coal.

Figure 2 illustrates the general geologic structure in the vicinity of the Keystone site (12) and figure 3 depicts the overall extent of the mine workings. Most of the mine workings were situated on the northwest limb of the Fayette anticline, although southeast portions of the mine crossed the anticlinal axis. According to a mine map dated 1941, the main mine entries were driven upgradient from an outcrop at a structural low point of the coal seam. Most of the initial mine development occurred to the east and southeast of the mains, also slightly upgradient with respect to geologic structure. A few panel headings were driven to the southwest, approximately along strike, but these were much shorter in length and did not support extensive room development. This pattern of mining suggests that the entries were laid out such that water would drain away from the working faces and toward the portals. When the mains reached the axis of the Fayette anticline, extensive sets of panel entries and rooms could be driven

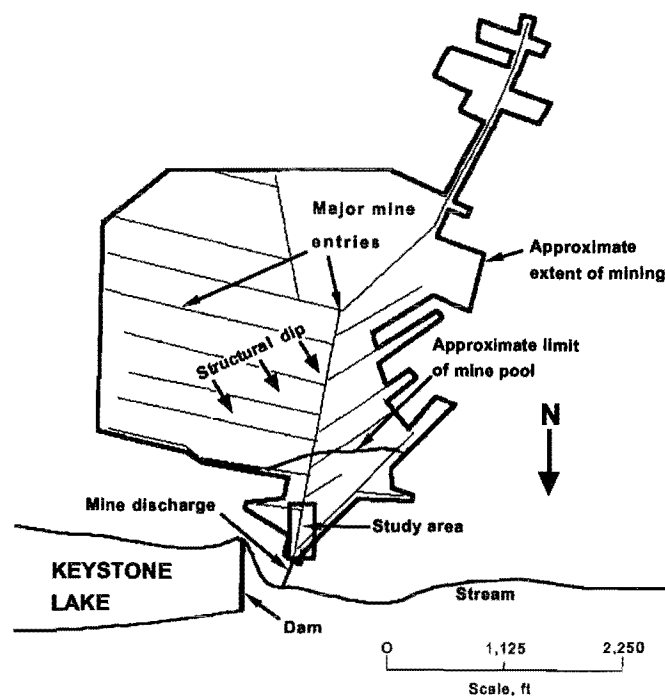
Figure 3.—Approximate boundaries of deep mine and mine pool, Keystone site.

this represented mine pool leakage through solid strata, as suggested by the general location of the pool and the structural dip (fig. 3). However, this seepage undoubtedly represented a negligible source of mine pool outflow compared with the main discharge.

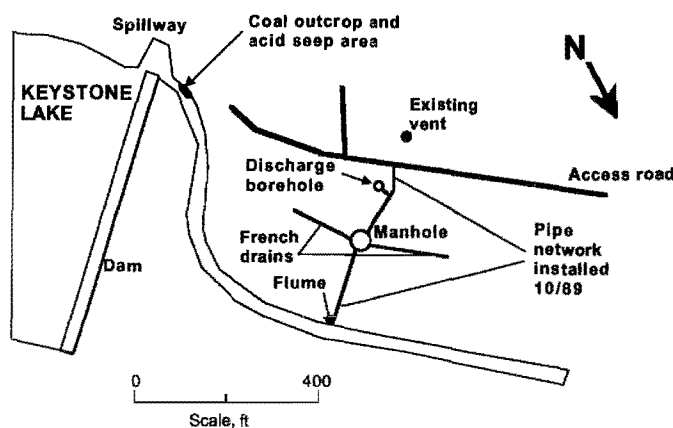
Figure 4.—Pipe network at mine discharge, Keystone site.

Figures 2 and 4 also show the location of the Keystone mine discharge with respect to the receiving stream and Keystone Lake, whose elevation usually controls the flow to the stream. The water quality of Keystone Lake is good (pH 8.4, no acidity, iron and manganese less than 1 mg/L, sulfate less than 50 mg/L), and supports a wide variety of fishing and recreational activities. However, the stream water quality begins to deteriorate immediately downstream of the spillway, where a diffuse seepage area enters the stream along its southern bank. A coal seam outcrop is located at the base of the spillway, and iron staining of the streambed was noticeable downstream from this point. The flow rate of this seepage could not be measured, but its presence was especially evident during low-water periods when spillway flow was reduced. It is believed

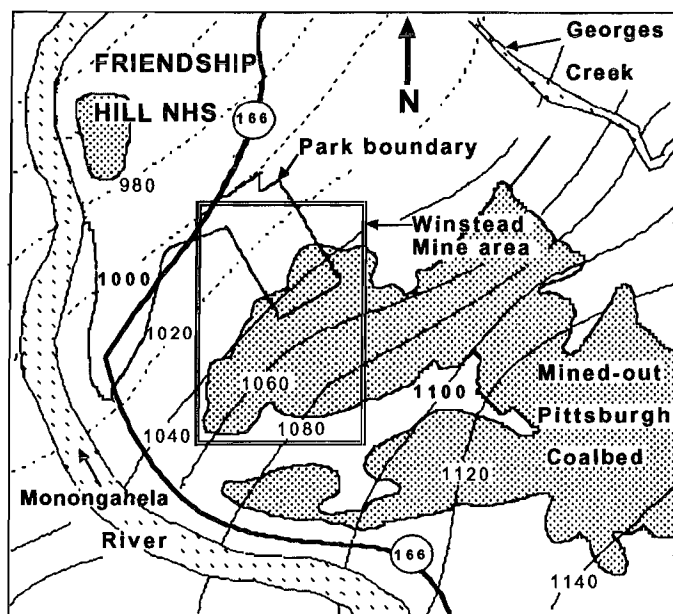
Figure 5.—Geologic structure of Friendship Hill site; structure contours on Pittsburgh Coal.

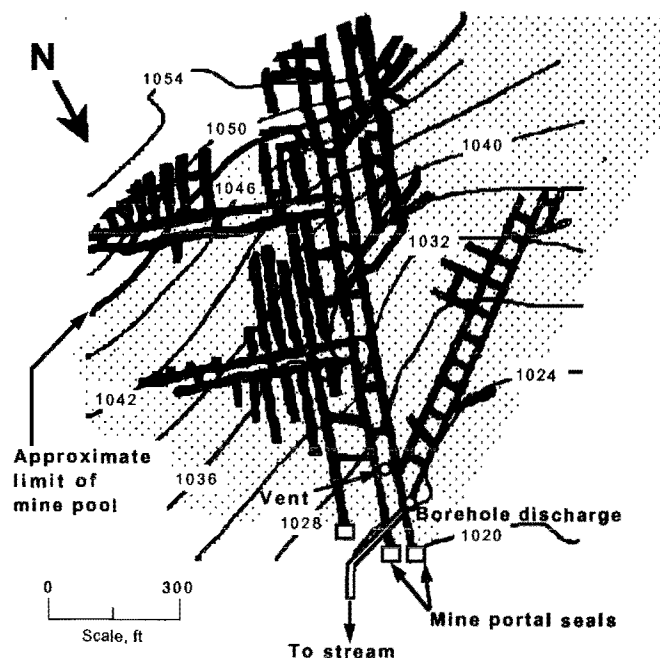
Figure 7.—Mine floor contours and pool limit, Keystone site.

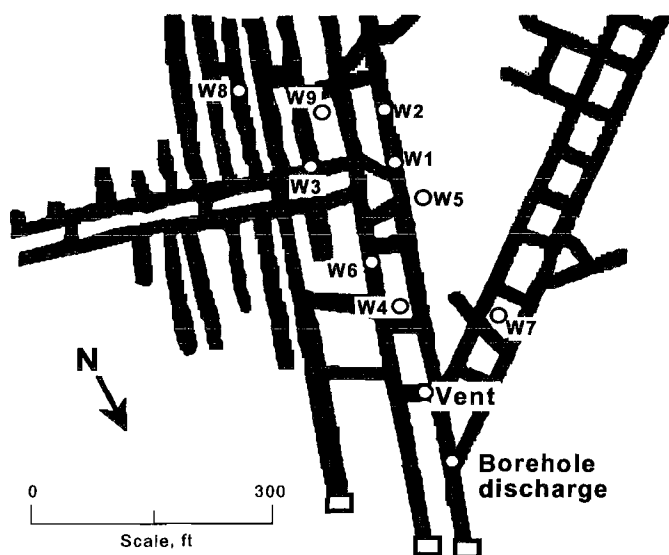
Figure 8.—Monitoring well locations, Keystone site.

was in a submain (well 3), and one was in a room entry (well 8). Four of the wells penetrated solid coal (wells 4, 5, 7, and 9). All drill holes had a 6-1/4 in diam and were cased with 4-in diam PVC pipe. In void wells, the annulus between the casing and hole was grouted completely from the top of the mine void to the surface. In wells penetrating solid coal (pillar wells), 10-ft-long screens with annular sand packs were installed through the coal and isolated from the grout by a 2-ft layer of bentonite. Figure 9 illustrates the general construction of the wells, and table 1 lists their elevations and depths.

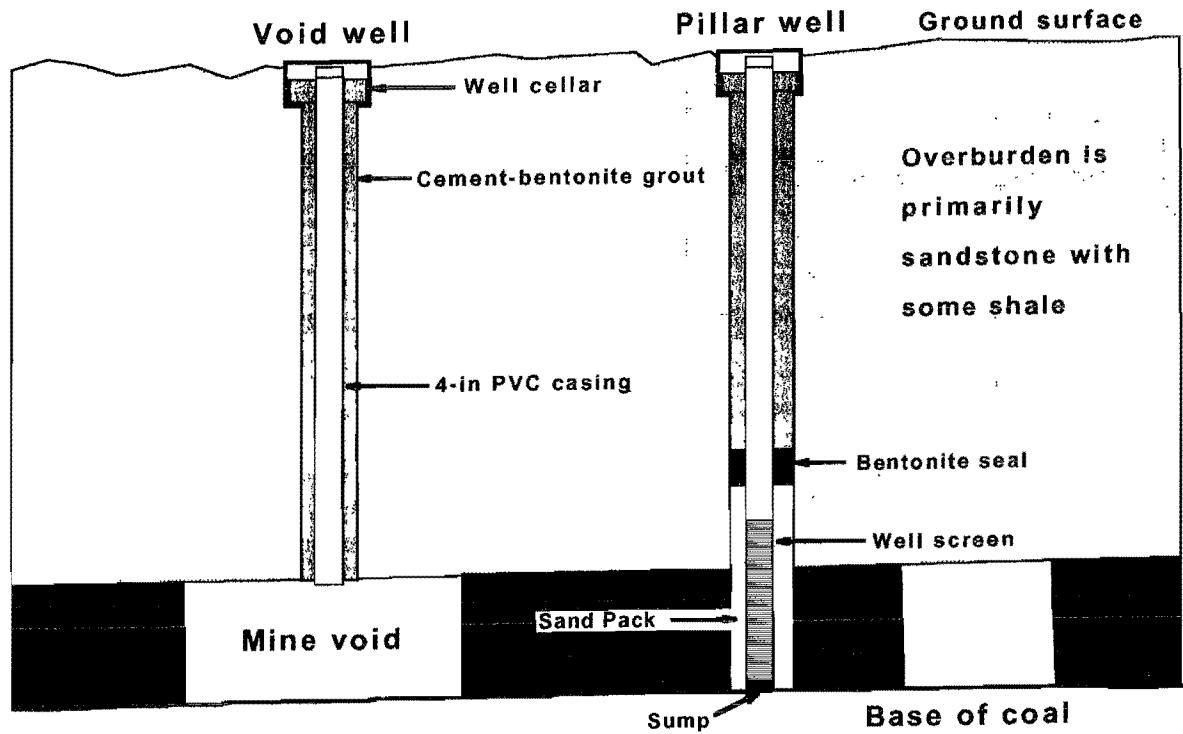
Figure 9.—Mine pool monitoring well construction.

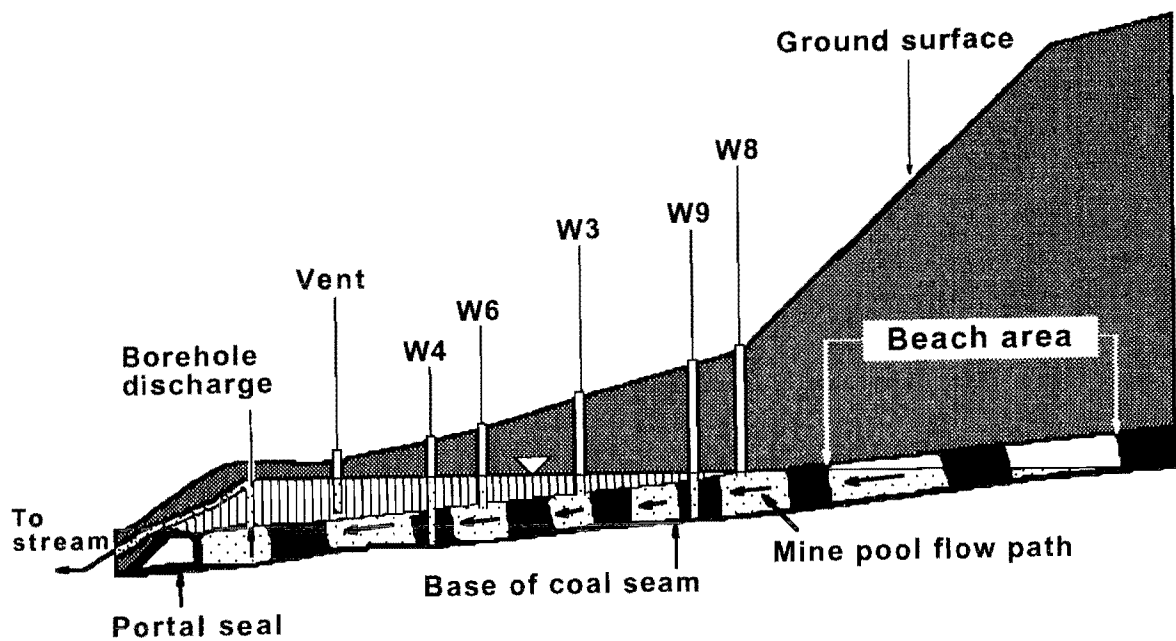
Figure 10.—Cross section of mine pool, Keystone site (vertical exaggeration 3.5:1).

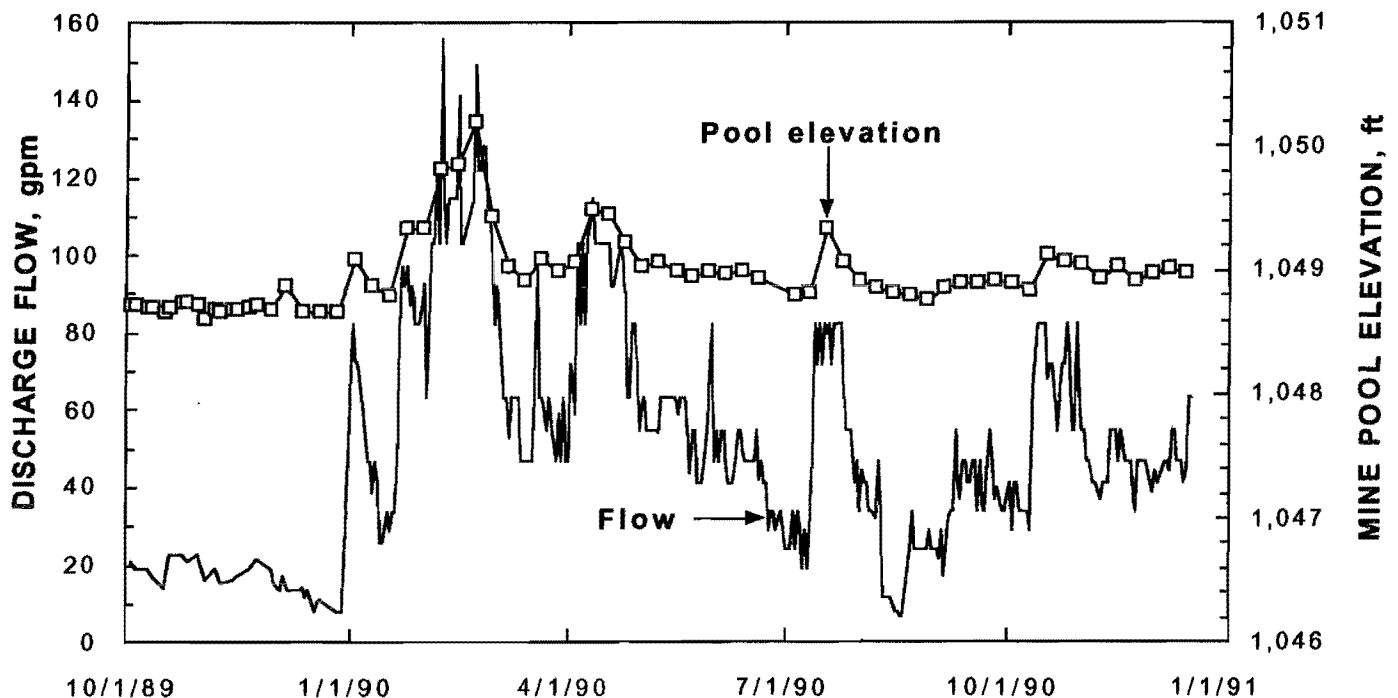
Figure 11.—Mine discharge flows and pool elevations, Keystone site.

Mine discharge flow rates were measured at least twice weekly with a portable flume for a period of more than 1 year. From October 1989 through mid-December 1990 the measured flow rates varied from 7 to 156 gpm, with a mean of 45, standard deviation of 33, and median of 37 gpm. Mine pool elevations were measured at least weekly throughout the study period. The average mine pool elevation showed little variation, fluctuating over a range of only 1.59 ft; however, a strong linear correlation was found between pool elevation and discharge flow rate. Figure 11 shows that the pool elevation and discharge flow rate rose and fell together throughout the study period, while figure 12 clearly illustrates the strong linear correlation (coefficient of determination,  $r^2 = 0.942$ ). This expected functional relationship is determined by both the head in the mine pool and the conditions at the discharge borehole.

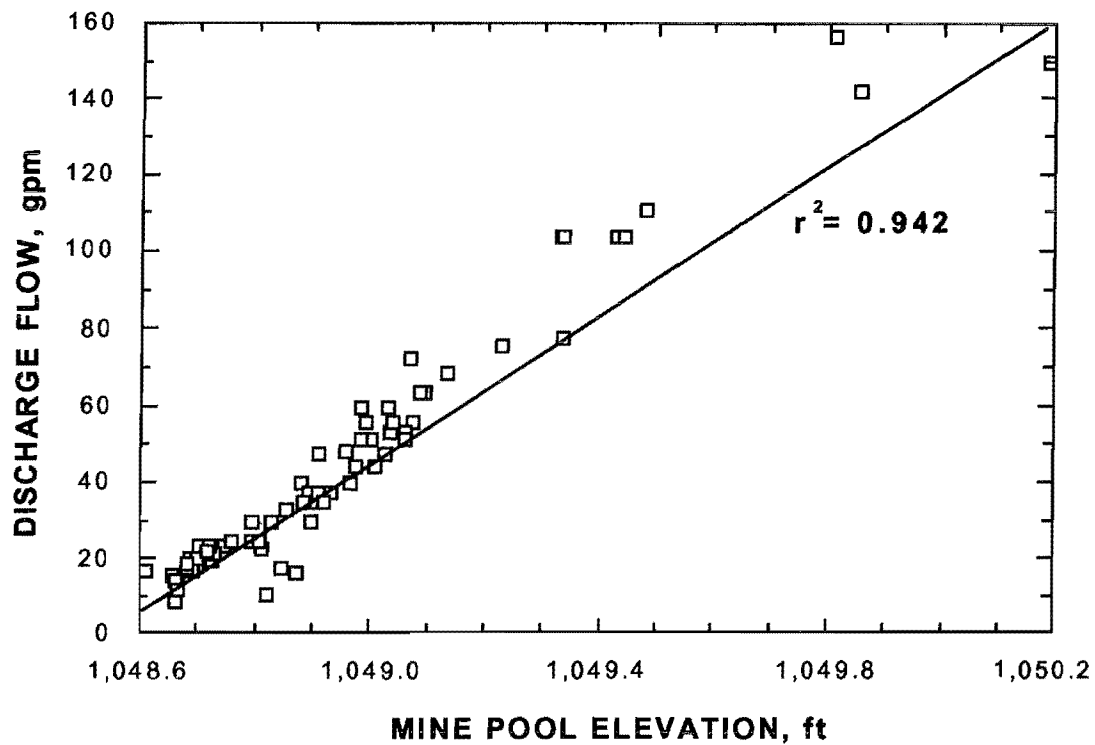
Figure 12.—Linear regression—mine pool level versus flow, Keystone site, 10/89 - 12/90.

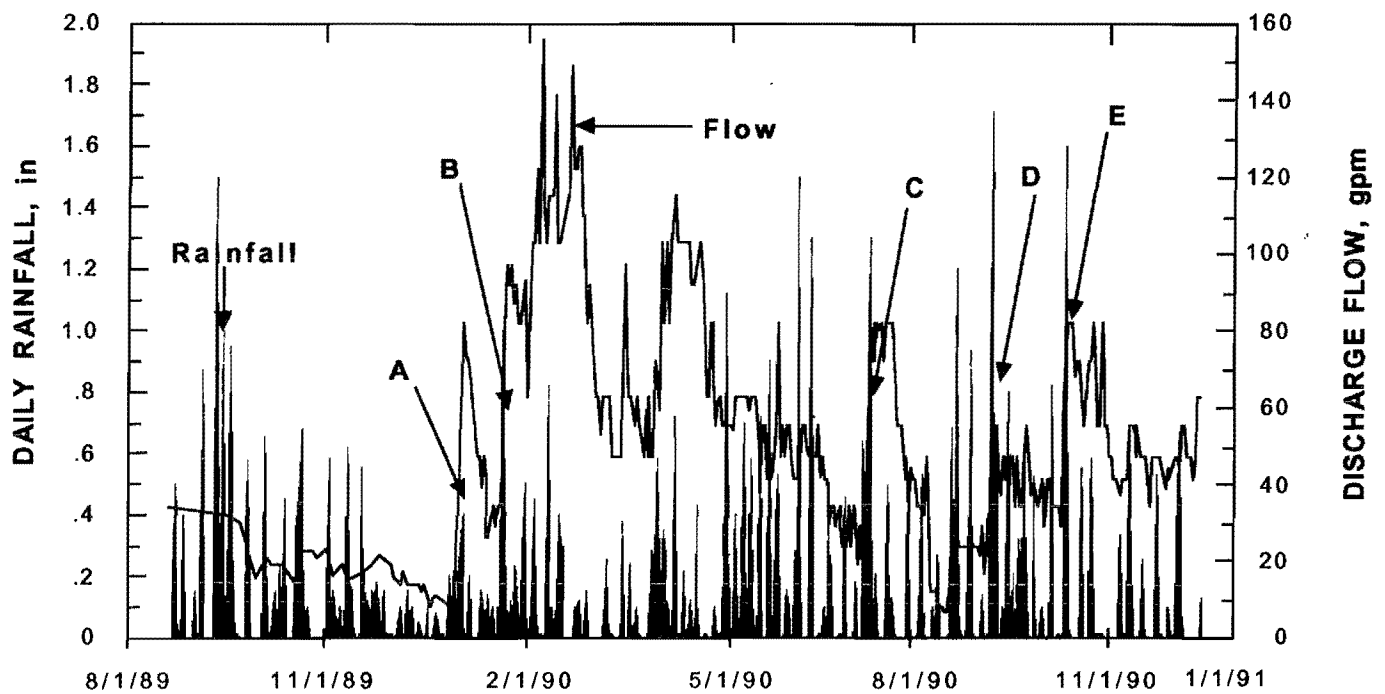
Figure 13.—Mine pool response to precipitation, Keystone site; events A and B denote winter response; events C, D, and E denote summer-fall response.

Note in figure 13 that the response of the mine pool to rainfall was much more pronounced during the winter and spring than during the summer and fall. For example, the pool did not respond significantly to large precipitation events that occurred during October and November 1989. One reason for this lack of response is that precipitation in the summer and fall often occurs in storms of relatively high intensity and short duration. During these events, a higher percentage of rainfall would become surface runoff (and less would infiltrate into the ground) than during events of lower intensity and longer duration. Also, although evapotranspiration rates were not measured, evapotranspiration rates in the Eastern United States are typically highest in the summer months. Therefore, the moisture-retaining capacity of the surface soils, subsoils, and fractures in the unsaturated overburden would have been relatively high in the fall. Much of the precipitation that infiltrated the surface during this time would have served to resaturate the soil and overburden and would not have recharged the mine pool. Conversely, large and

rapid pool responses coincided with rainfall and snowmelt events on December 26, 1989 through January 2, 1990, and January 18-22, 1990, (events A and B in figure 13), despite the fact that these events were no larger than those that had occurred during the fall. Prior to these responses, a steady series of rainfall and snowmelt events may have combined with lower evapotranspiration rates to allow the moisture content of the overburden to approach field capacity. The onset of additional precipitation and infiltration then would have caused rapid recharge to the mine pool and the subsequent increases in pool level and flow. This pattern of large, rapid pool responses continued through April 1990.

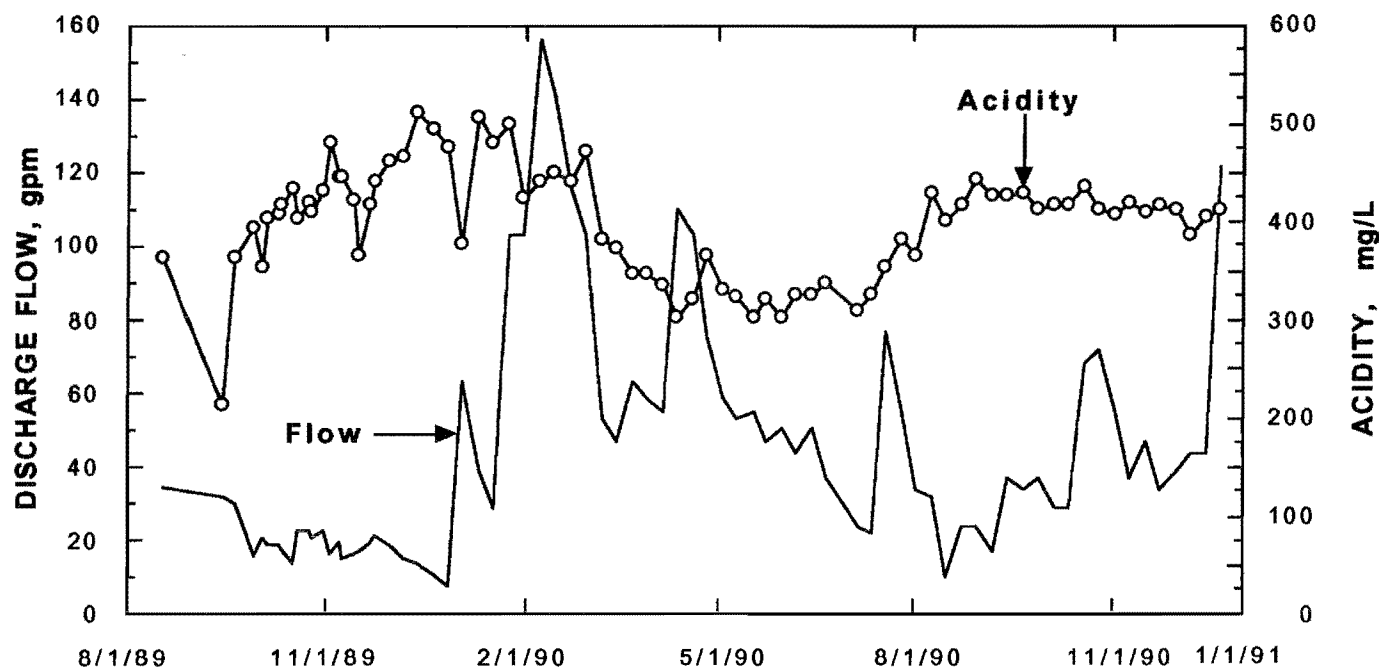
Figure 14.—Acidity concentrations at mine discharge, Keystone site.

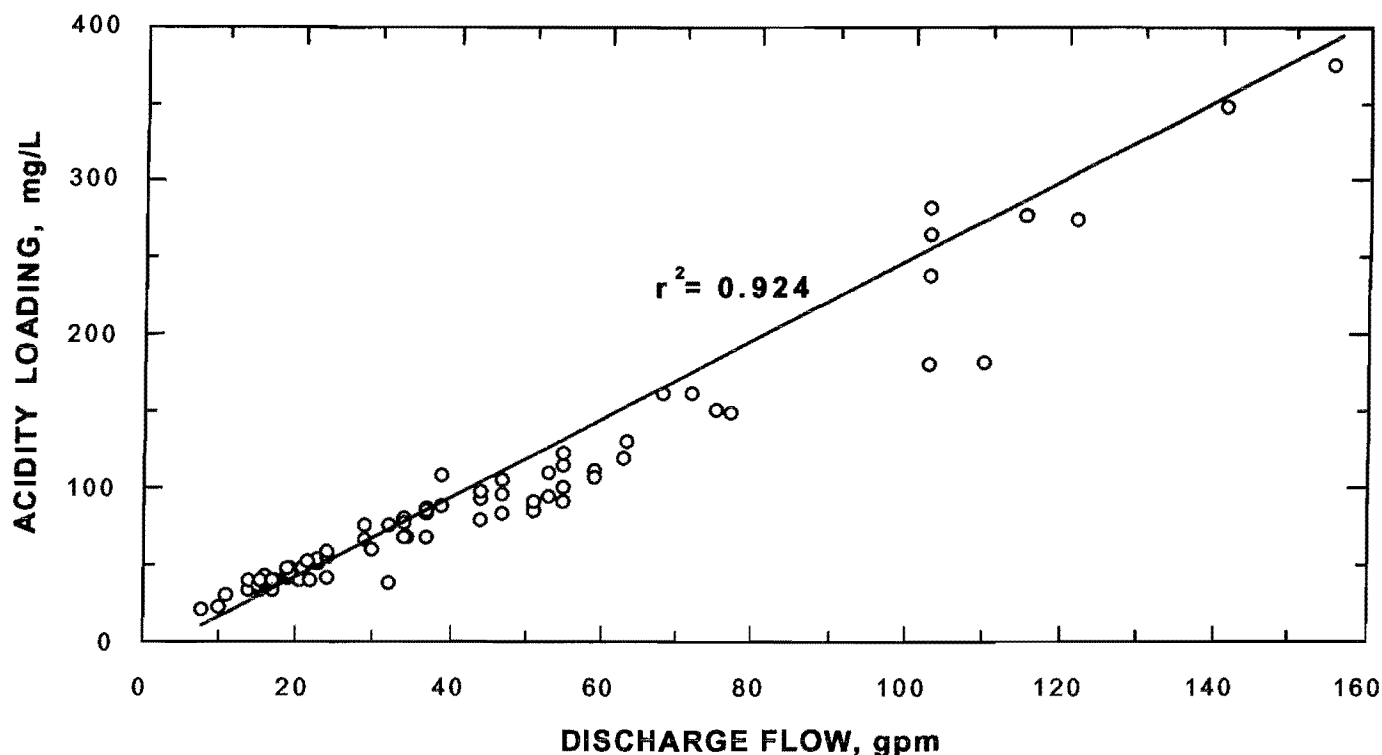
Figure 15.—Linear regression—flow versus acidity loading, Keystone site.

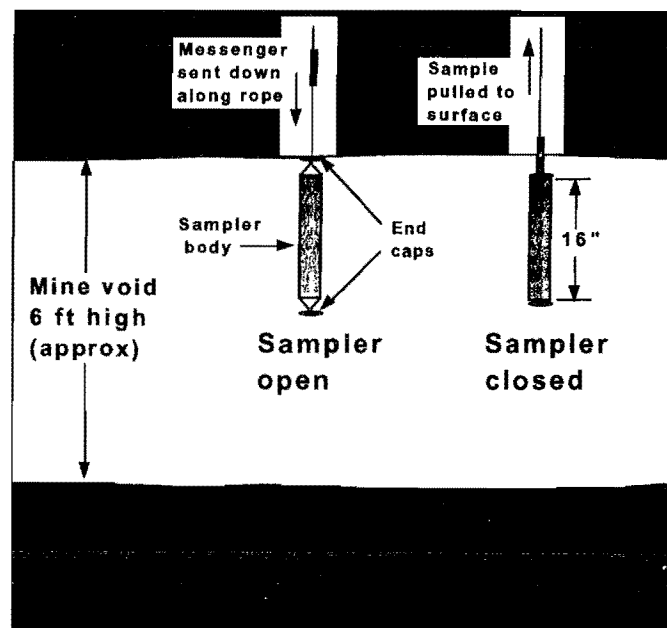
Figure 16.—Interval sampler used in mine voids.

The intercepted mine voids were about 5 to 9 ft high (table 1). For initial comparisons, water quality samples were collected from the approximate centers of the voids (2.5 to 4.5 ft above bottom at each well) with an interval sampler, as illustrated in figure 16. Water quality samples in the pillar wells were collected with a bailer after a minimum of three well volumes of water had been purged, or until the well had been bailed completely dry and allowed to recover. Figure 17 compares the average values of the six major water quality parameters commonly associated with acid mine drainage (pH, acidity, total iron, sulfate, aluminum, and manganese) for the mine void wells, the pillar wells, the vent hole, and the mine discharge. The differences in contaminant concentrations among the five void wells were minor, so they were averaged for comparison in figure 17; the same was true for three of the four pillar wells (5, 7, and 9). The significant differences in water quality between the pillars and voids supported the assumptions that lateral flow occurred mainly through the voids, and that the pillars were recharged from above rather than from the side.

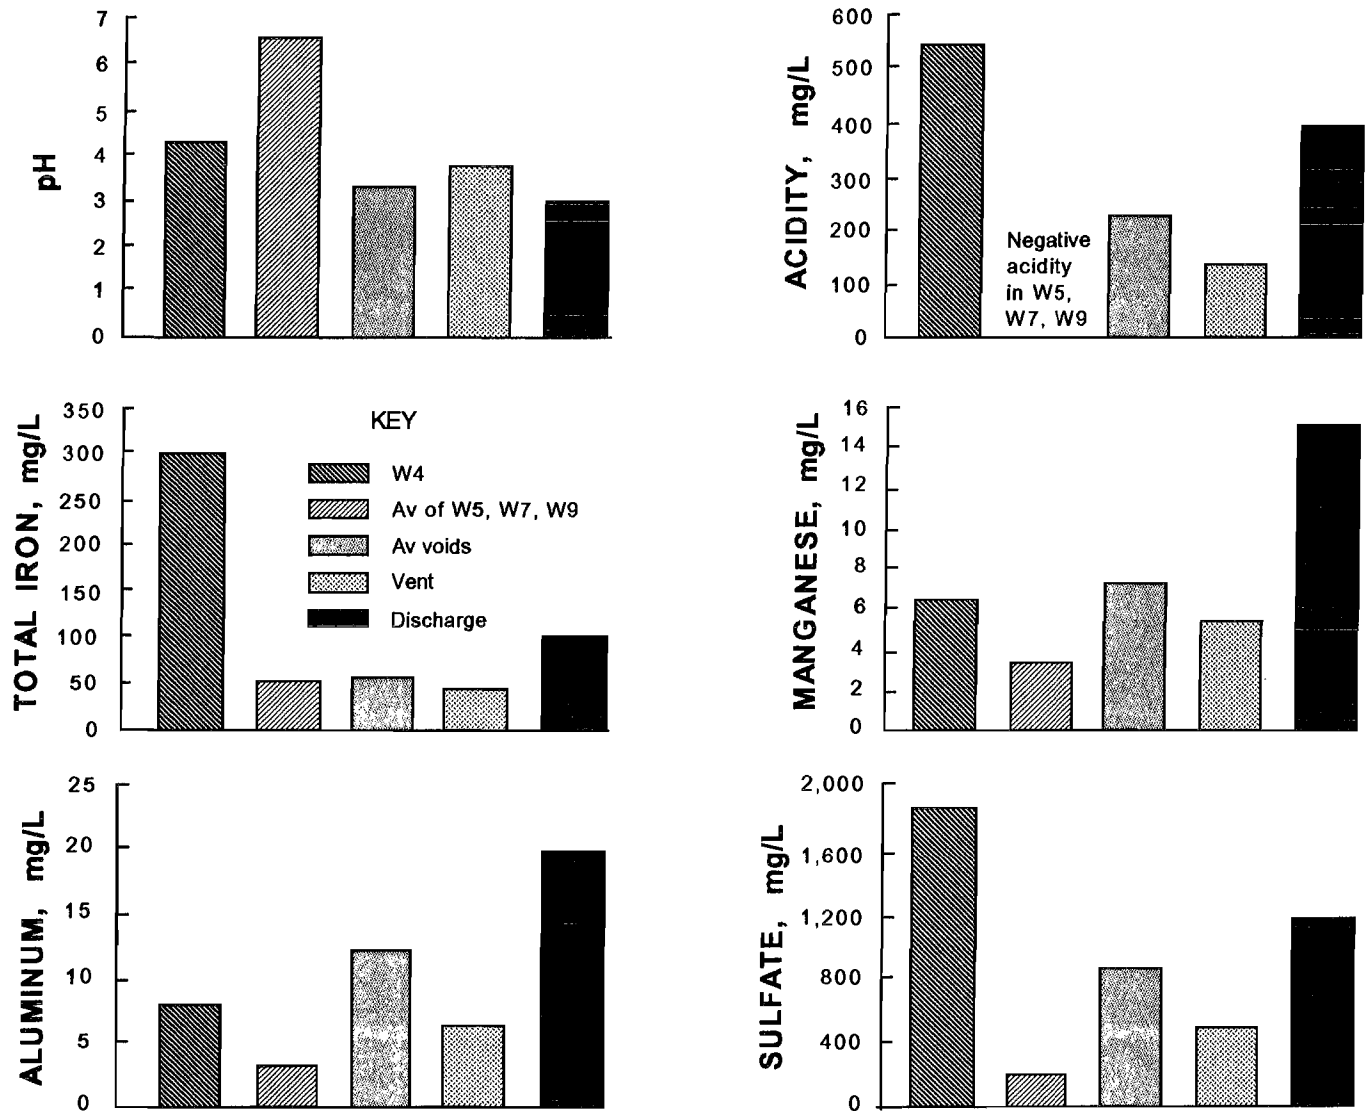
Figure 17.—Average water quality in monitoring wells and mine discharge, Keystone site.

In this regard, the extremely poor water quality of well 4 was quite anomalous. Acidity, total iron, and sulfate concentrations in well 4 were consistently higher than in either the voids or the discharge, while pH was higher and aluminum and manganese concentrations were lower. Clearly, acid mine drainage existed at well 4, but the source of the acidity cannot be accurately identified. For reasons described above, lateral flow from an adjacent contaminated entry was considered unlikely. One possibility is that a localized zone of pyritic overburden or coal existed at well 4. Further research to investigate the cause of the poor water quality at well 4 was beyond the scope of this study.

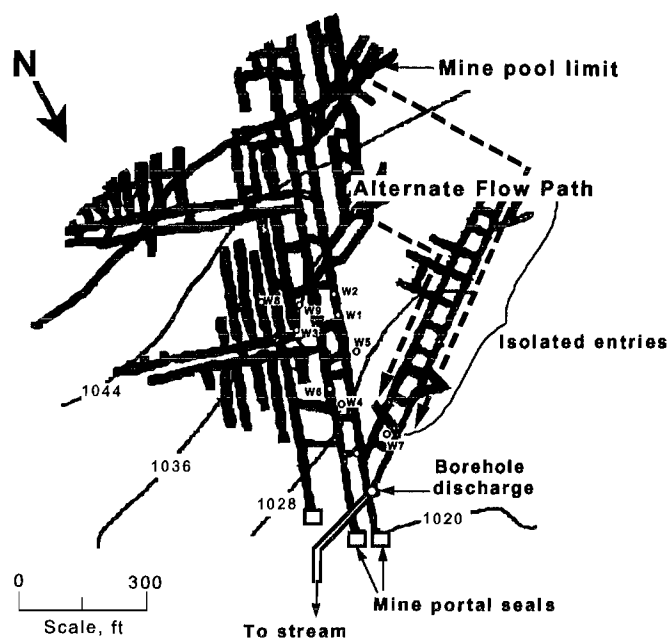
Figure 18.—Alternate mine pool flow path, Keystone site.

If the second flow scenario described above were true, flow through all entries would not be uniform as previously assumed, and the flow velocity through the monitored mine entries would be very slow. Under near-stagnant conditions, waters at different levels in the voids would not mix, and a marked worsening of mine water quality with depth would occur (14). In order to check for such water-quality stratification, the interval sampler shown in figure 16 was used to collect water samples from the top, center, and bottom of the voids. Samples from all voids were grouped by level and statistically analyzed to check for water quality differences between levels. As shown in figure 19, the water quality at the top of the voids was significantly better than at the center or bottom. Although the water quality at the center appeared to be somewhat better than at the bottom, the overlap of the confidence intervals prevented a definitive conclusion. These data suggested that some degree of stratification was occurring within the monitored voids, and that the flow velocity was relatively slow. It was decided that further experimentation would be necessary to define the flow rate through these entries, which would ultimately determine their suitability for alkaline injection.

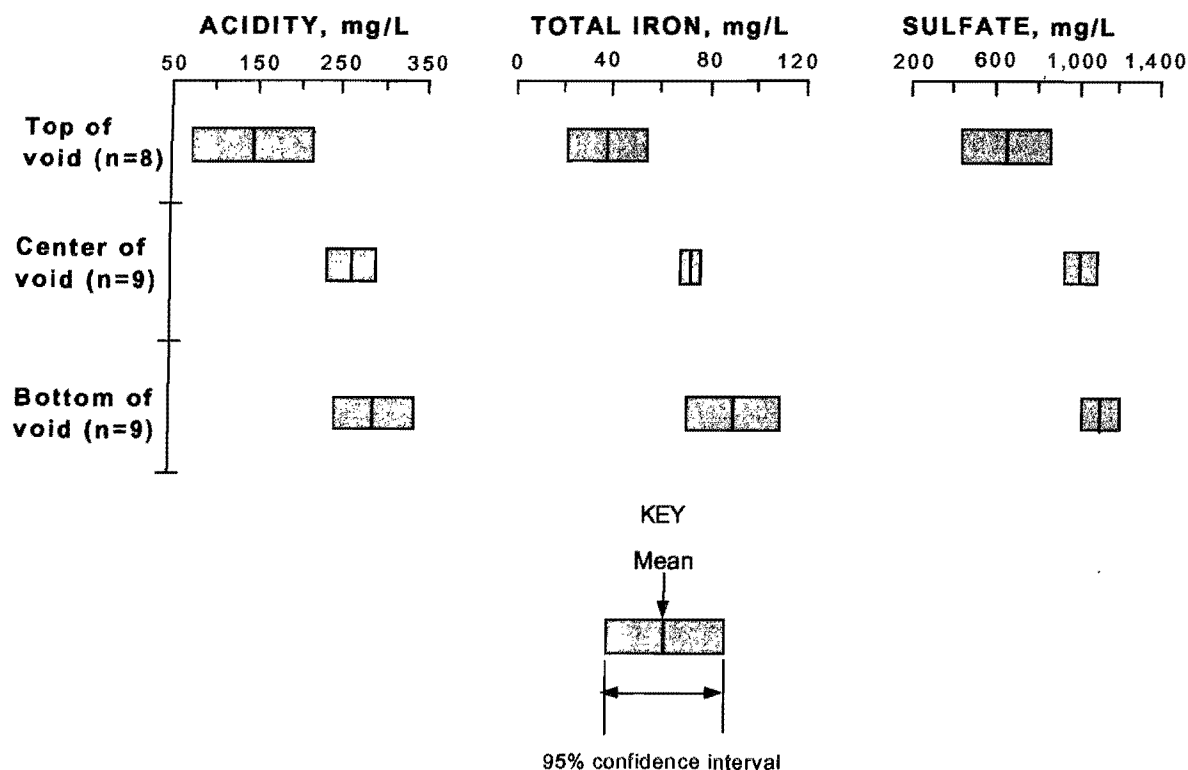
Figure 19.—Stratification of water quality in mine voids, Keystone site.

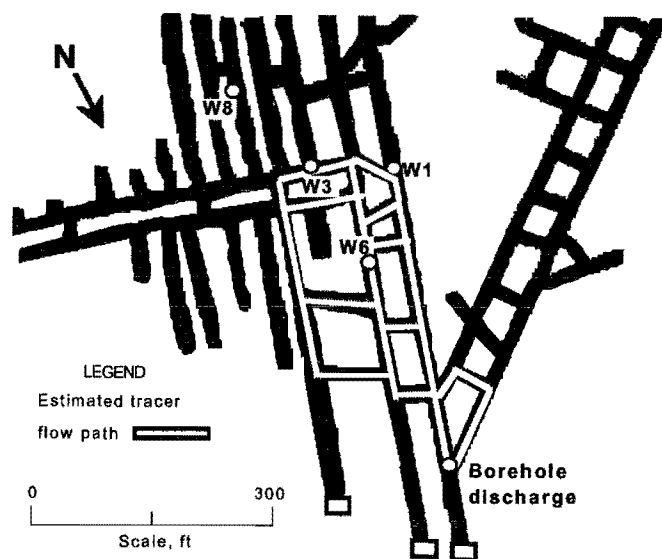
Figure 20.—Estimated flow path of bromide tracer, Keystone site.

Results of the tracer test suggested that flow was not uniform through all open entries. After 92 days of sampling, no trace of bromide was detected at the discharge or at wells 1 or 6, which were on the assumed flow path from well 3 to the discharge. During this time, the mean discharge flow rate was 76 gpm, or 14,644 ft<sup>3</sup>/d; under the uniform flow assumption, the flow velocity in the vicinity of well 3 would have been approximately 25 ft/d. Under these circumstances, traces of bromide would be expected in well 1 after 4 days, well 6 after 10 days, and at the

discharge after 22 days. Obviously, flow was not occurring uniformly through all open entries as first assumed. However, the apparent migration of bromide away from well 3 (fig. 21) indicated that water in that entry was not completely stationary. Immediately after tracer introduction and flushing, a sample taken at the center of the void at well 3 contained 468 mg/L of bromide; after 92 days, the concentration had declined to less than 1.0 mg/L (fig. 21). This decline could not be attributed to molecular diffusion because the initial bromide concentration was too dilute to produce significant solute movement via diffusion (16). Therefore, it was concluded that some flow, albeit slow, was occurring in the entry penetrated by well 3.

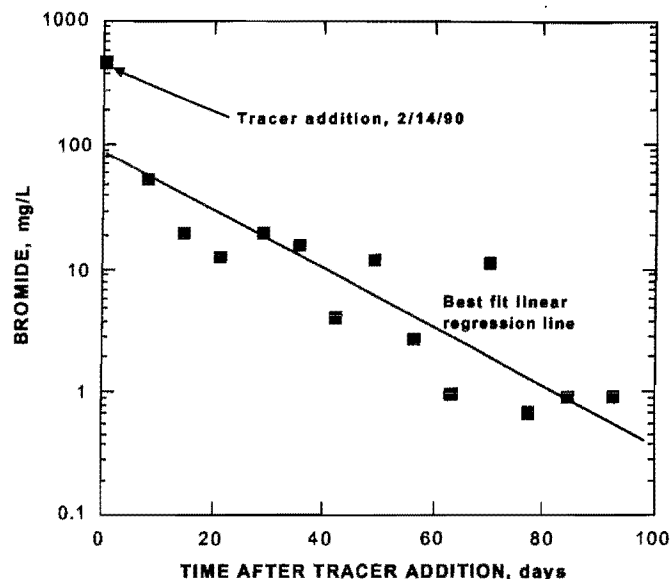
Figure 21.—Decline of bromide concentrations at well 3, Keystone site.

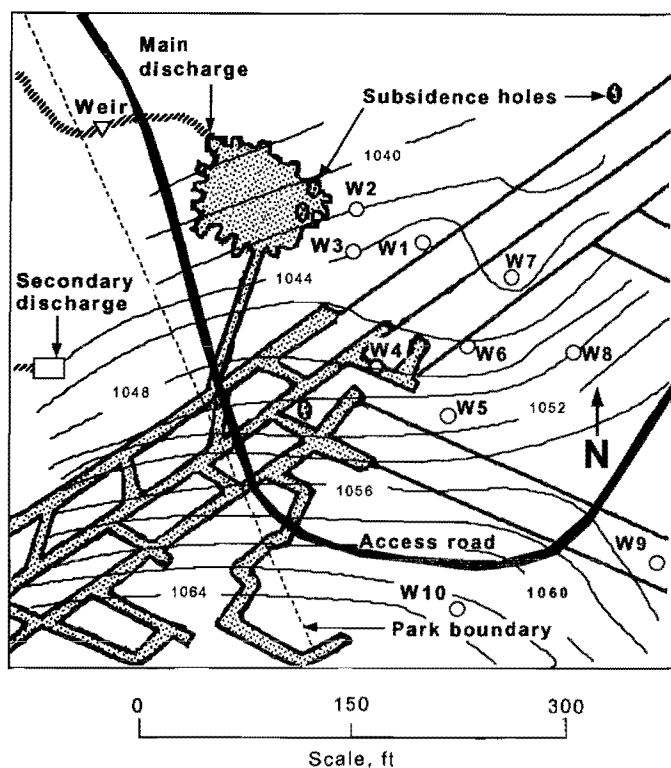
Figure 22.—Estimated seat clay contours, Friendship Hill site.

Figure 22 shows the locations of all monitoring wells with respect to the mine discharges, subsidence holes, and the site access road. The first three wells penetrated a

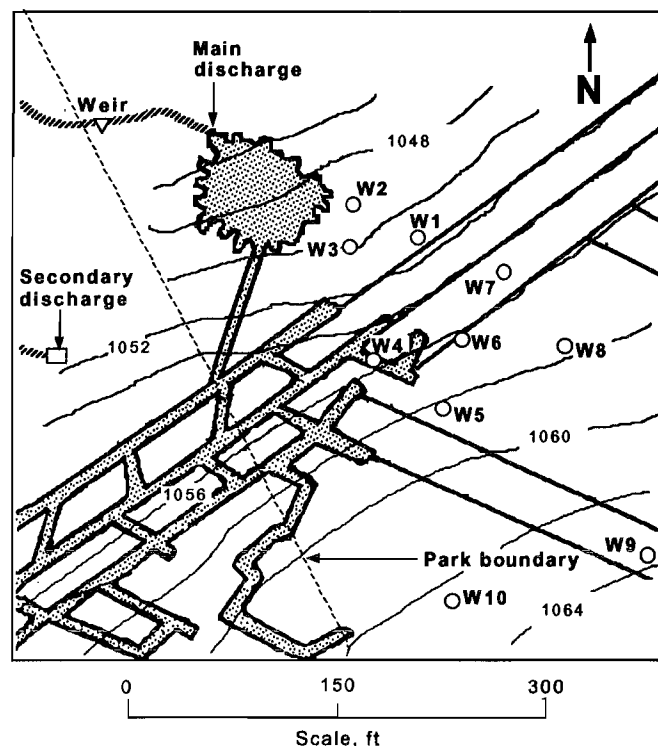
Figure 23.—Water elevation contours, Friendship Hill site.

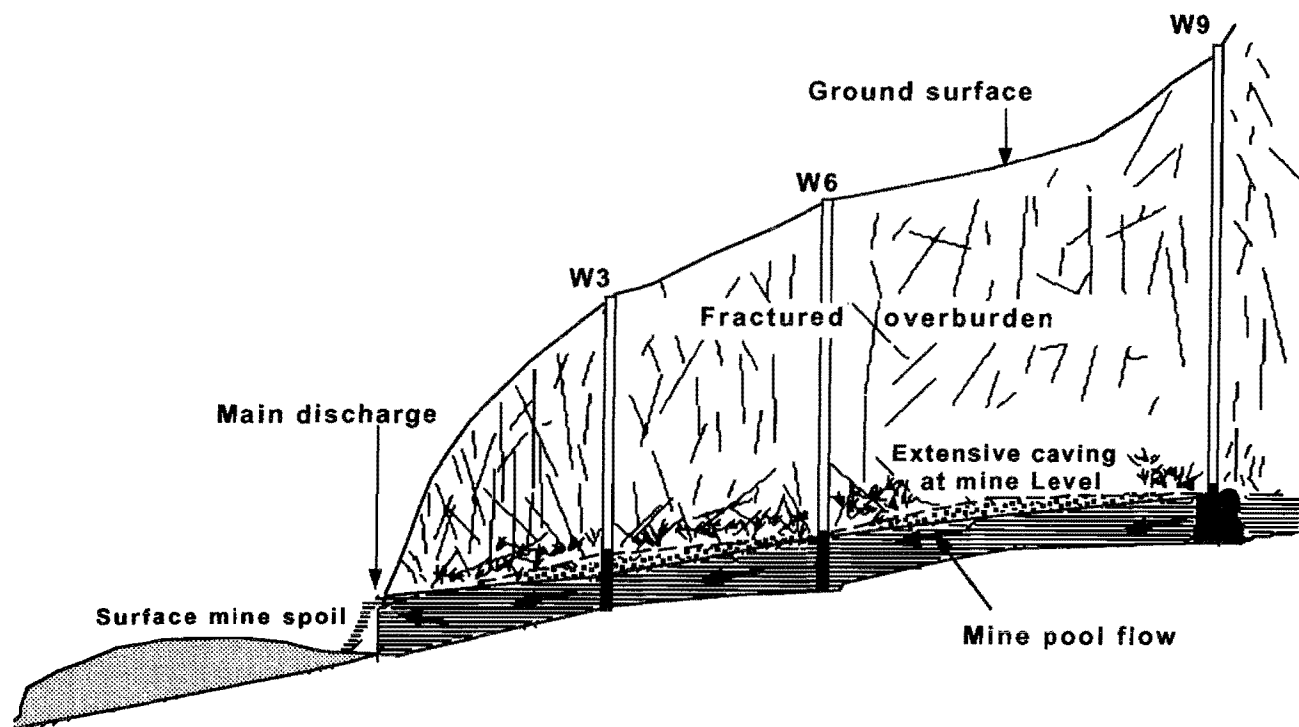
Figure 24.—Cross section of mine pool, Friendship Hill site (vertical exaggeration 4.4:1).

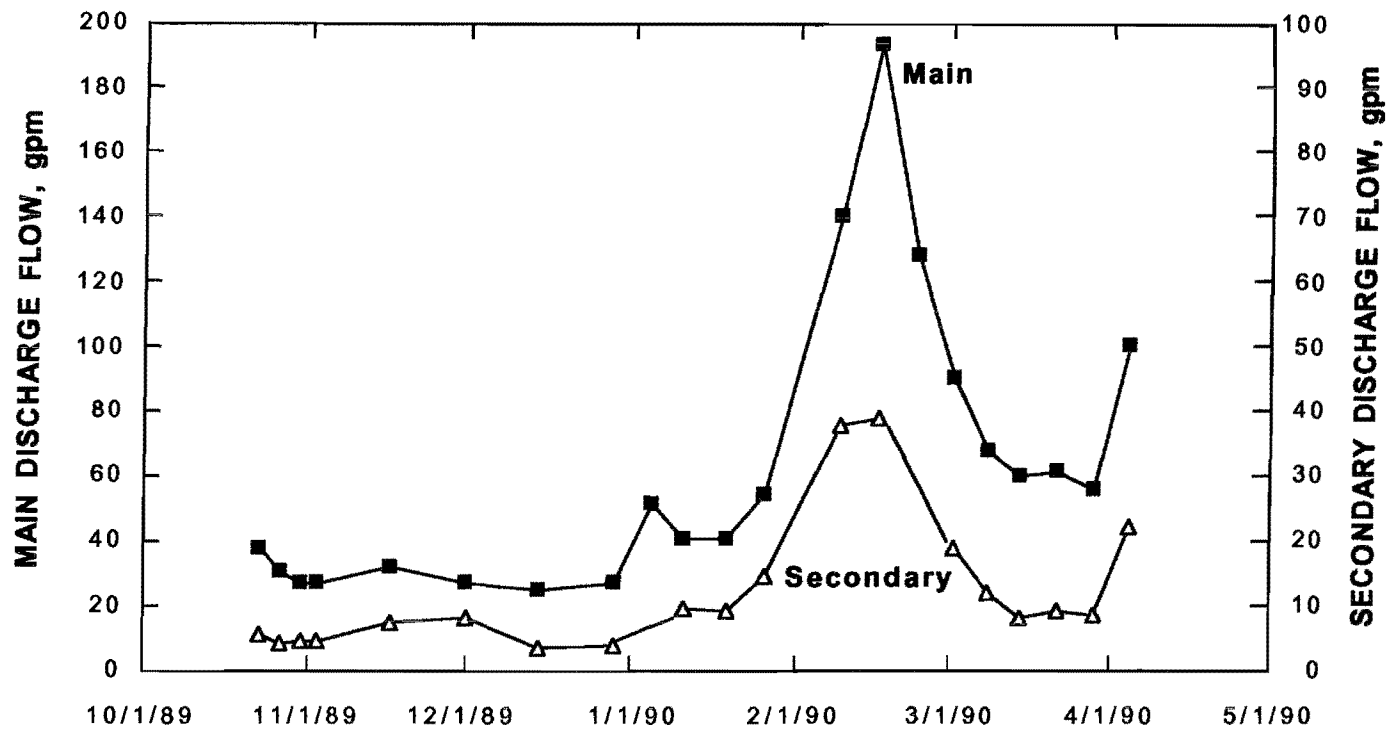
Figure 25.—Mine discharge flow rates, Friendship Hill site.

Figure 25 shows the flow rates of the two measured discharges over the 5-month period when secondary discharge flow rates were measured. The strong positive correlation between the flow rates at the main and secondary discharges (figure 26,  $r^2 = 0.832$ ) supported the assumption that the two were connected to the same mine

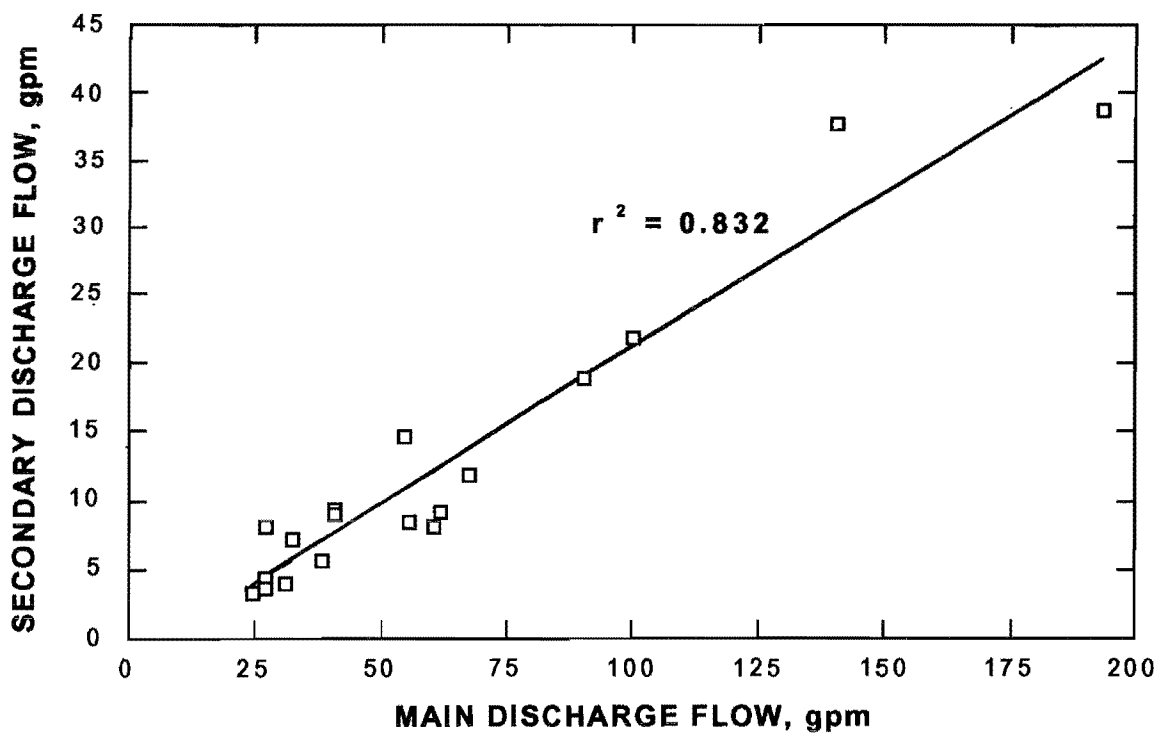
Figure 26.—Linear regression—flow rate at main discharge versus secondary discharge, Friendship Hill site.

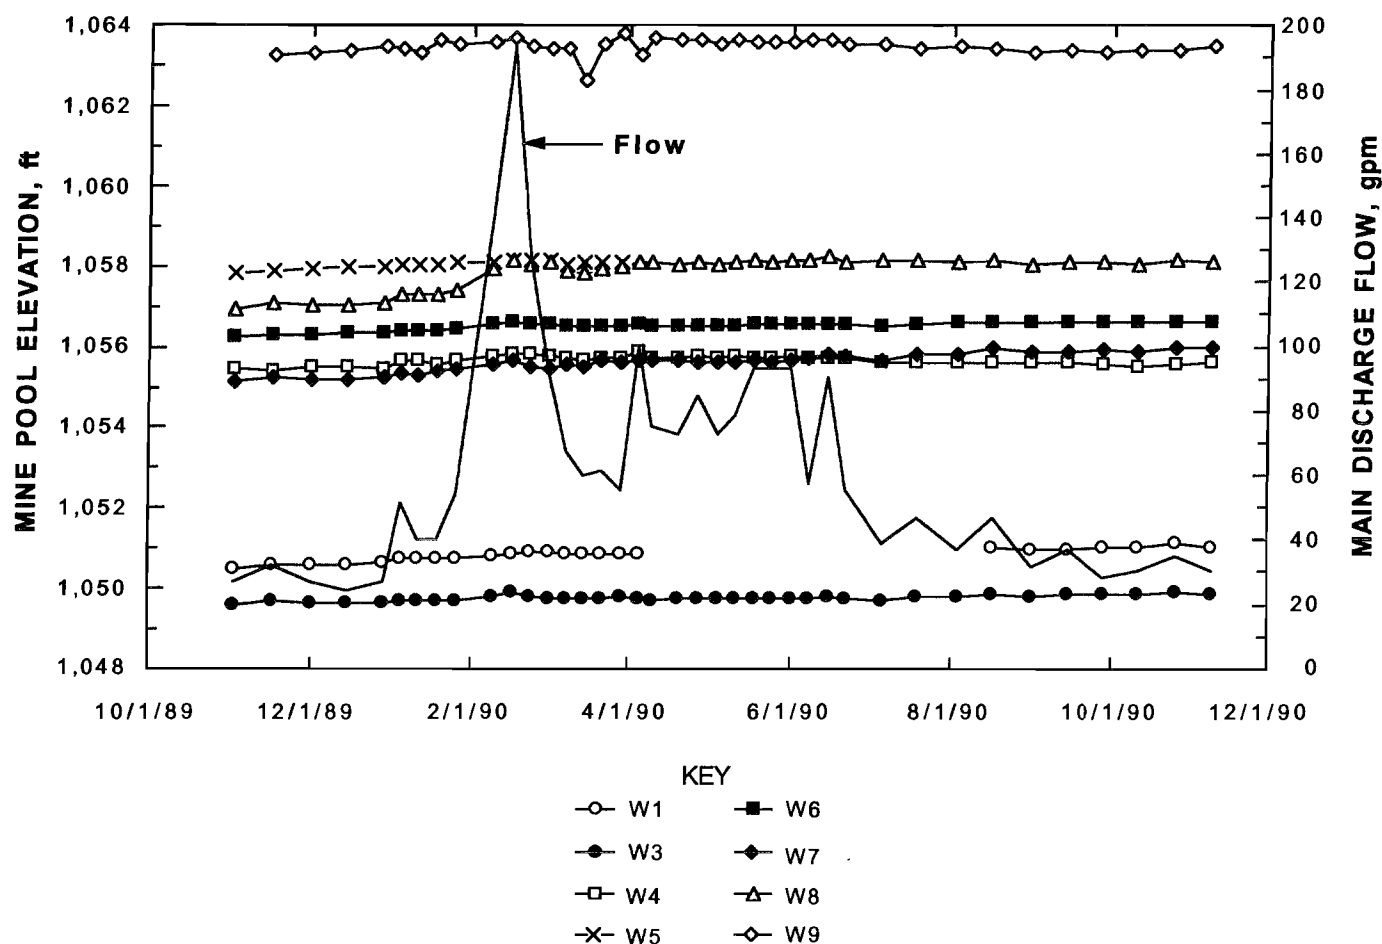
Figure 27.—Water elevations in monitoring wells, Friendship Hill site.

Water levels in all nine water-bearing monitoring wells were measured weekly from November 1989 through March 1990. After three of the wells were vandalized beyond repair in early April 1990, monitoring frequency was gradually decreased to twice monthly, but continued until early November 1990. The most remarkable finding was that the water levels in all wells remained almost the same throughout the study period despite the wide variations in discharge flow (fig. 27). This contrasted markedly from the Keystone site, where pool level fluctuations were small but easily detected. It appears that the large size and storage capacity of the pool and the presence of multiple discharge points may have rendered the changes in the mine pool level undetectable. Preliminary estimates of

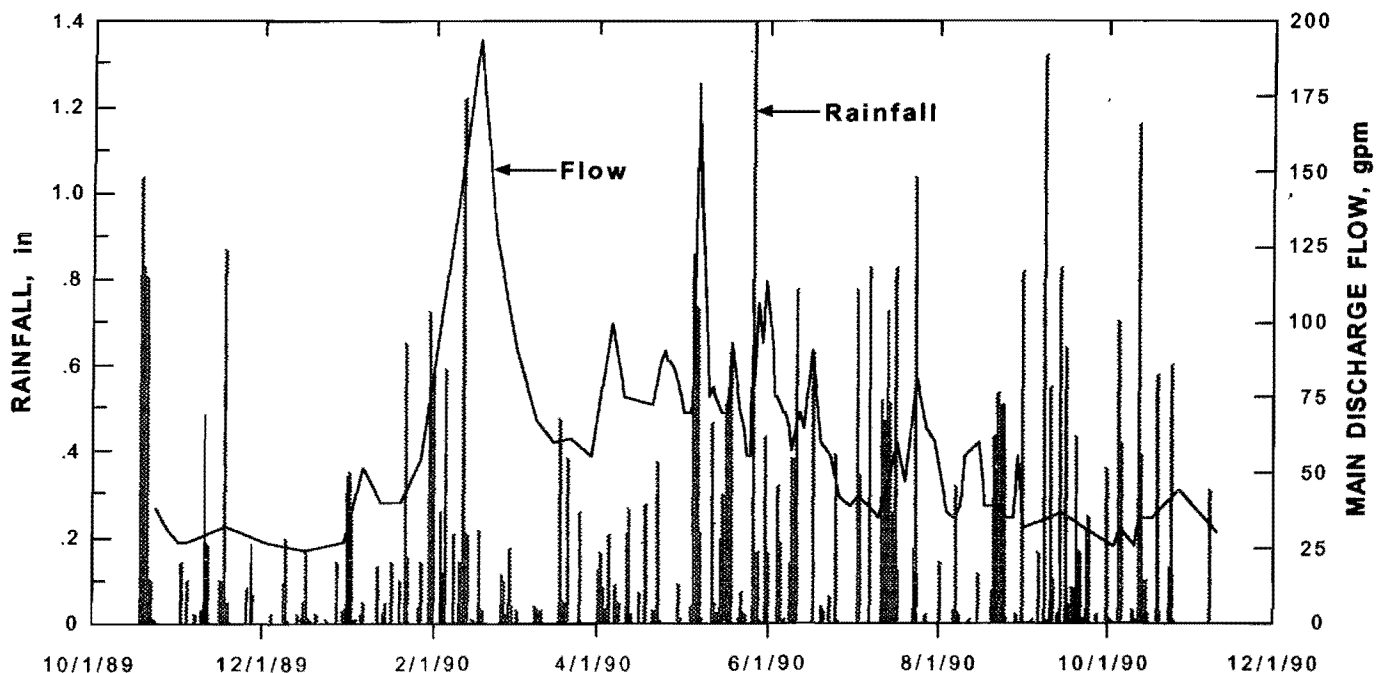
Figure 28.—Response of mine pool to precipitation, Friendship Hill site.
